Finca Punta Gorda in El Socorro, Tenerife
Installation Report

Installation report for SEM installation in Finca Punta Gorda in El Socorro, Tenerife.

Mars 31, 2012

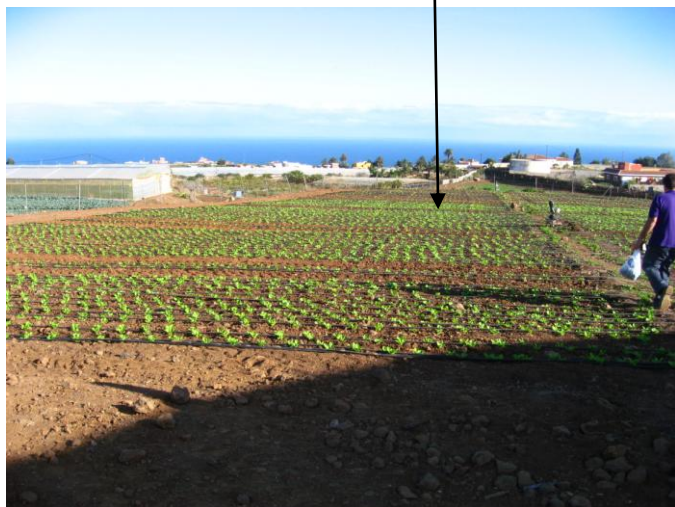
The whole sector and the sub sector where we install the SEM

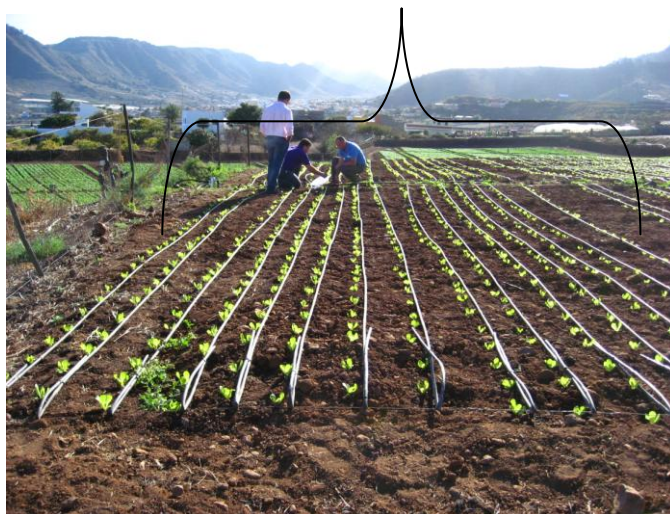
Sub sector where we install the SEM

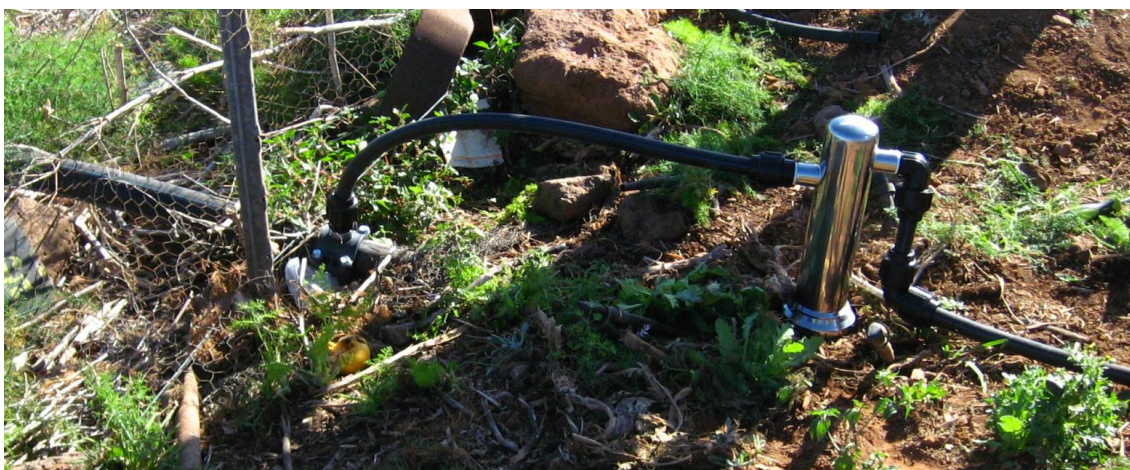
View of details, 2" pipe, the clamp-on 2" bracket with 3/4" outlet and the SEM

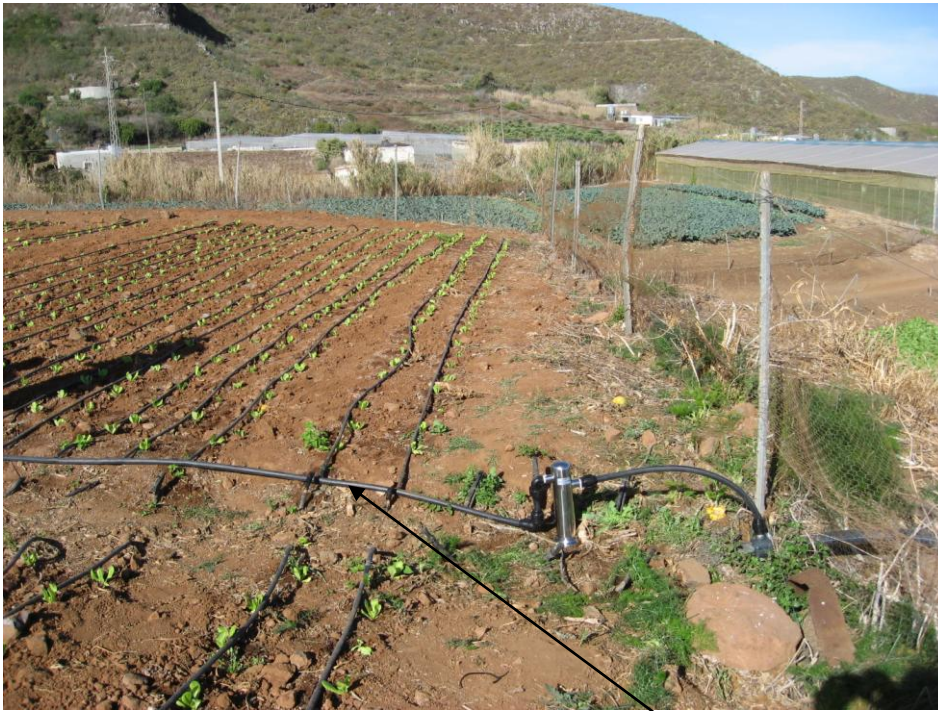
The installed SEM with the $\frac{3}{4}$ " supply pipe to the $\frac{1}{2}$ " drop irrigation hoses.

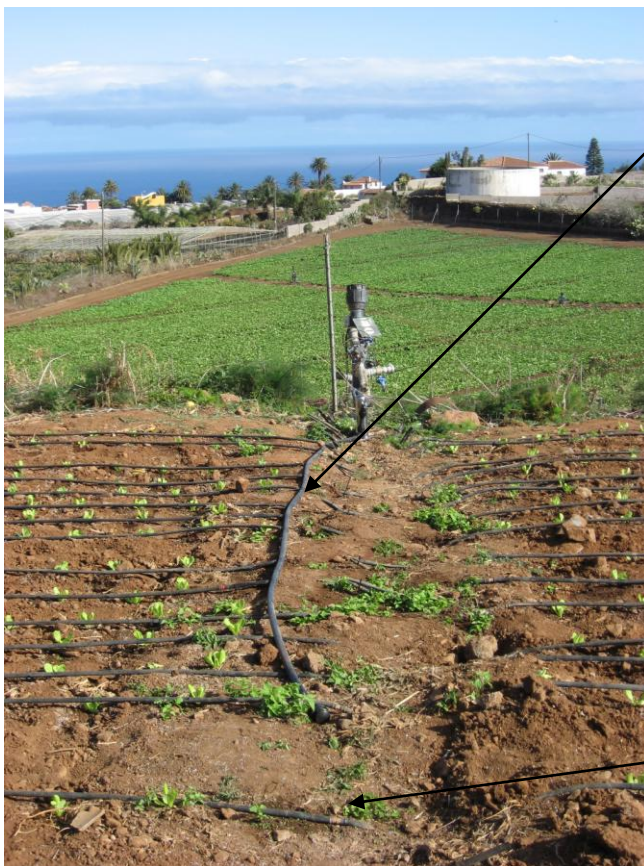
$\frac{3}{4}$ " supply line

When we receive the AVS, this is the point where we will do the same arrangement for the next sub sector that will be fed by the AVS.
